RELIABILITY SERIES 3 OF 5

DRONE CRASH CAUSES

#3 HUMAN FACTORS / GROUND CONTROL

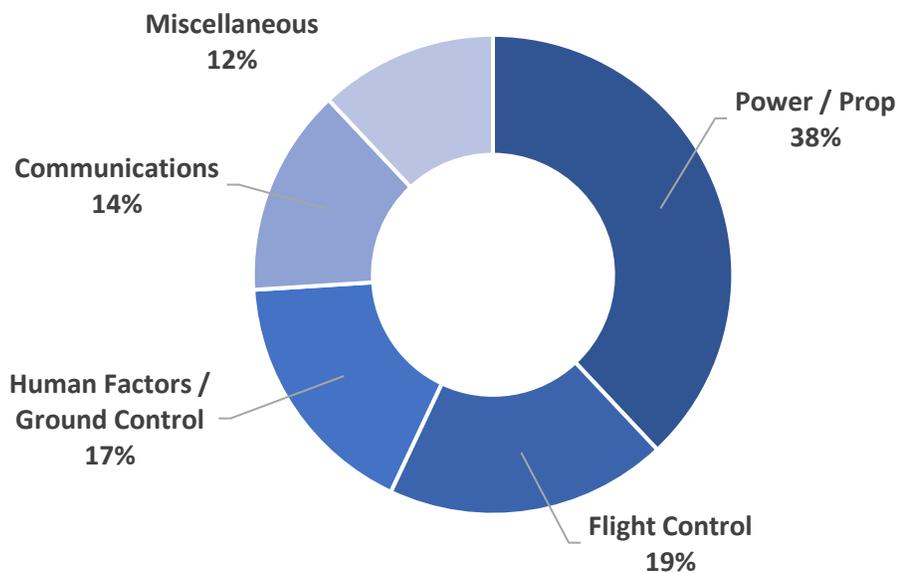
AVERAGE SOURCES OF SYSTEM FAILURES FOR U.S. MILITARY UA FLEET

- **Power/Propulsion (P&P).**
- **Flight Control.**
- **Human Factors/Ground Control.** Accounts for all failures resulting from human error and maintenance problems with any non-aircraft hardware or software on the ground
- **Communications.**
- **Miscellaneous.**
